Alternative #2
TRP#10-C
RESOLUTION NO. 10-04

RESOLUTION OF THE TOWN OF ST. LEO TOWN COMMISSION

RE: Tree Recommendations for 12704 Ridgeview Ct, Dade City, FL 33525

Pre-Development Tree Assessment

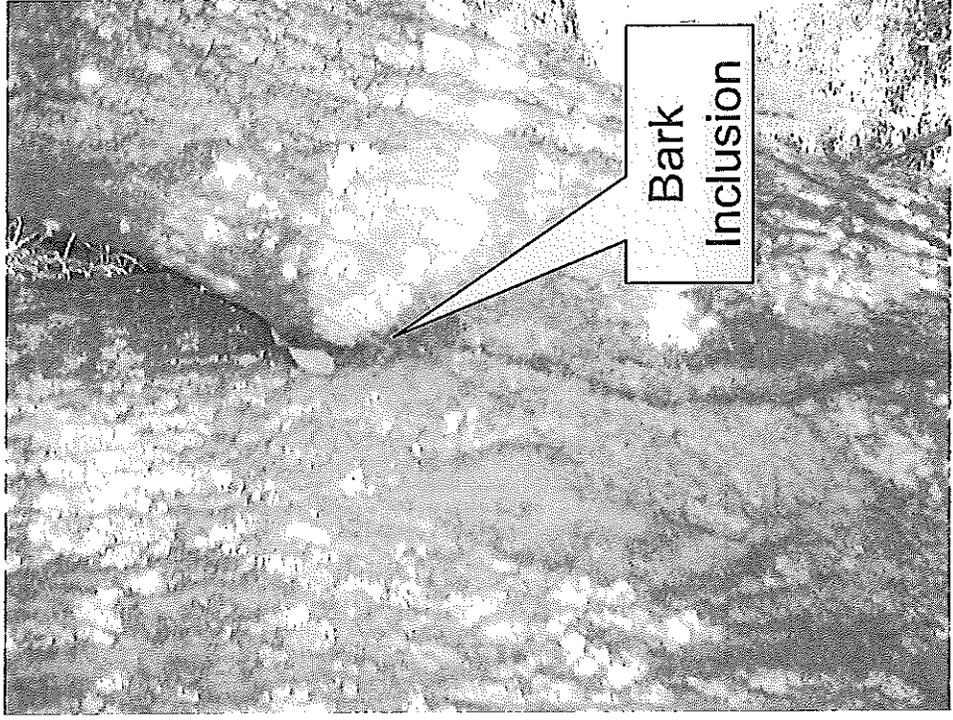
Bark
Inclusion

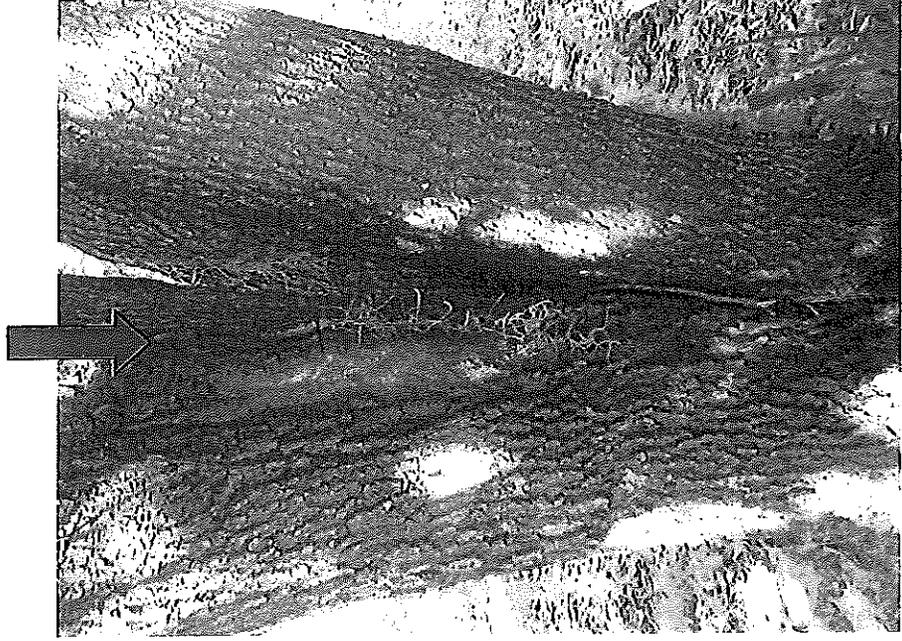
Tree No. 2, 3 & 4

Split in bases of
joining trees

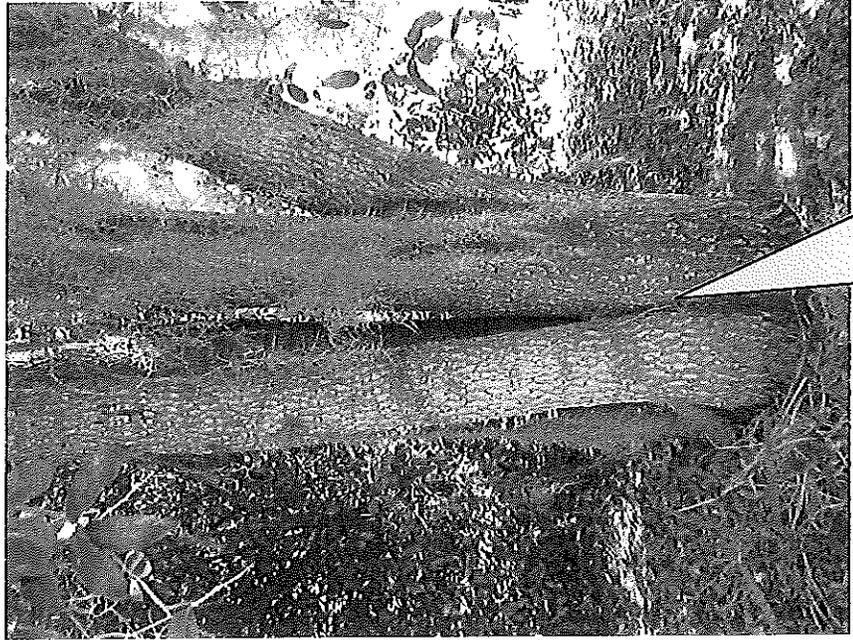
Weak
attachment

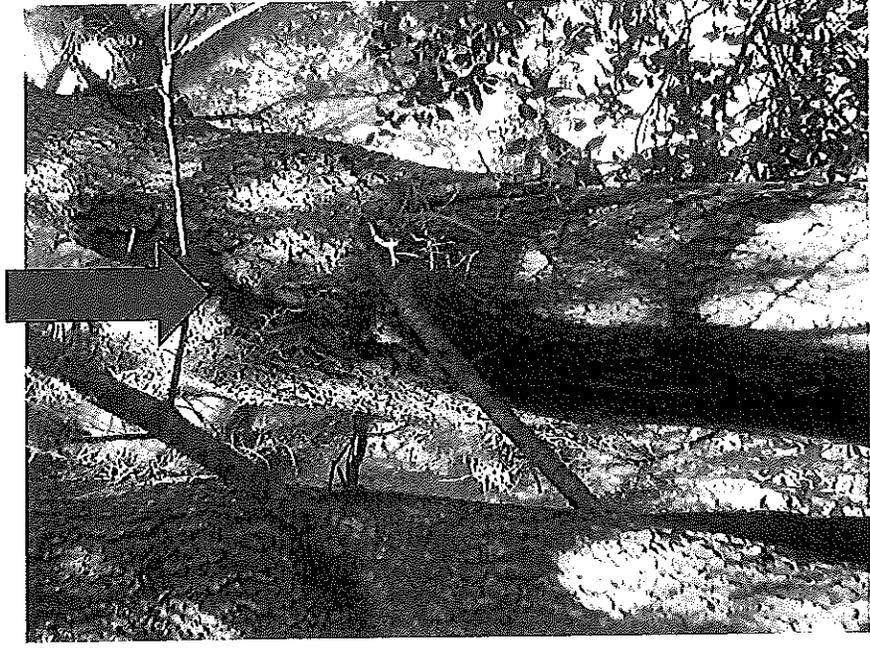
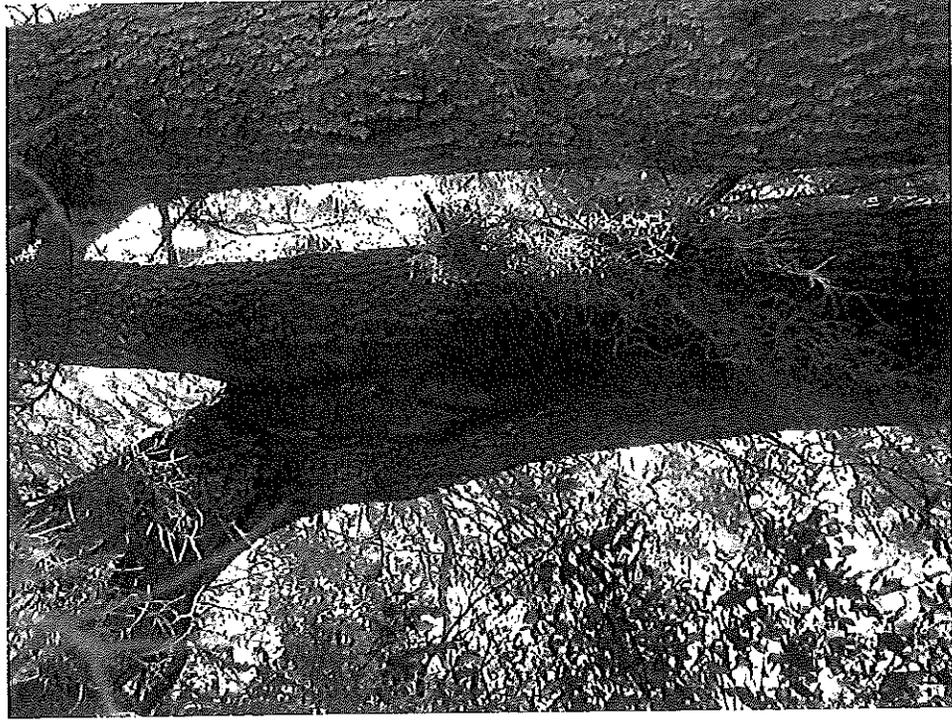
Tree No. 2, 3 & 4

Split in Co-dom. Stem (both pictures
from opposite side of tree)

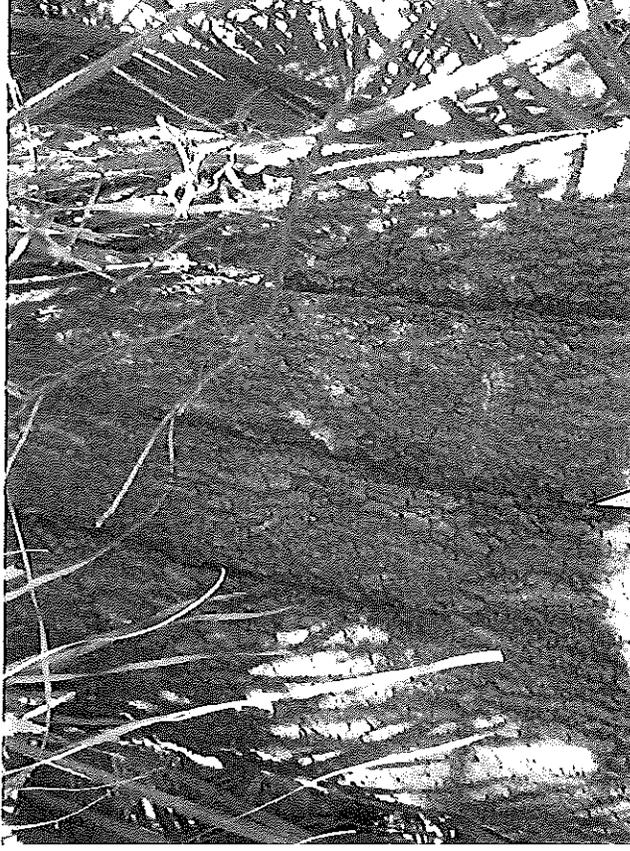
Fissures

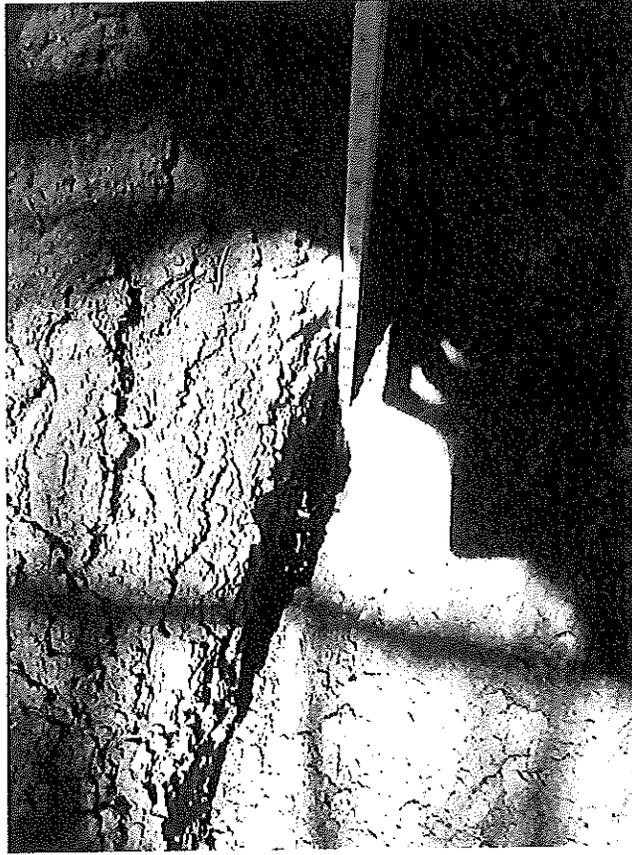
Tree No. 5

Cavity with decay (approx.
5 inches deep at base
of tree

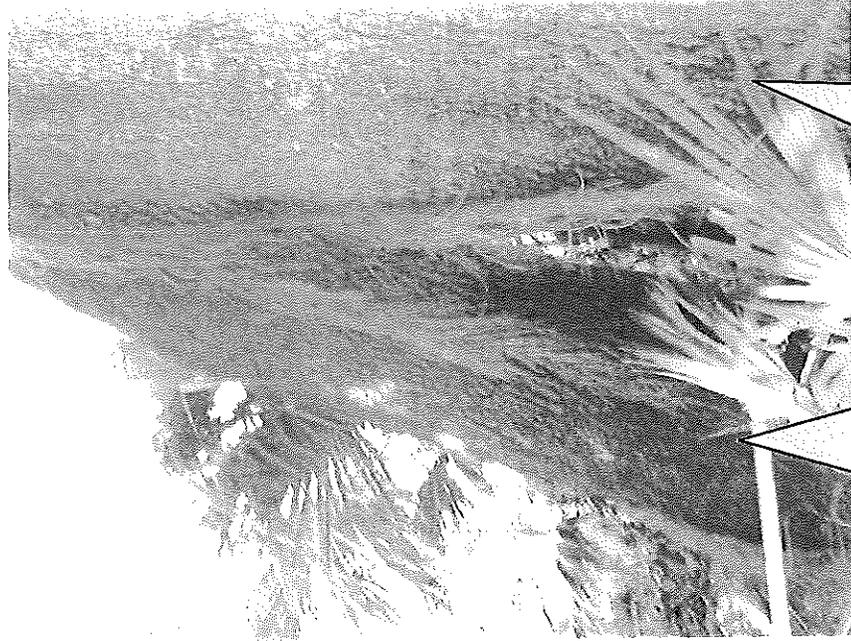
Trees No. 6 & 7

Tree No. 7
- leaning

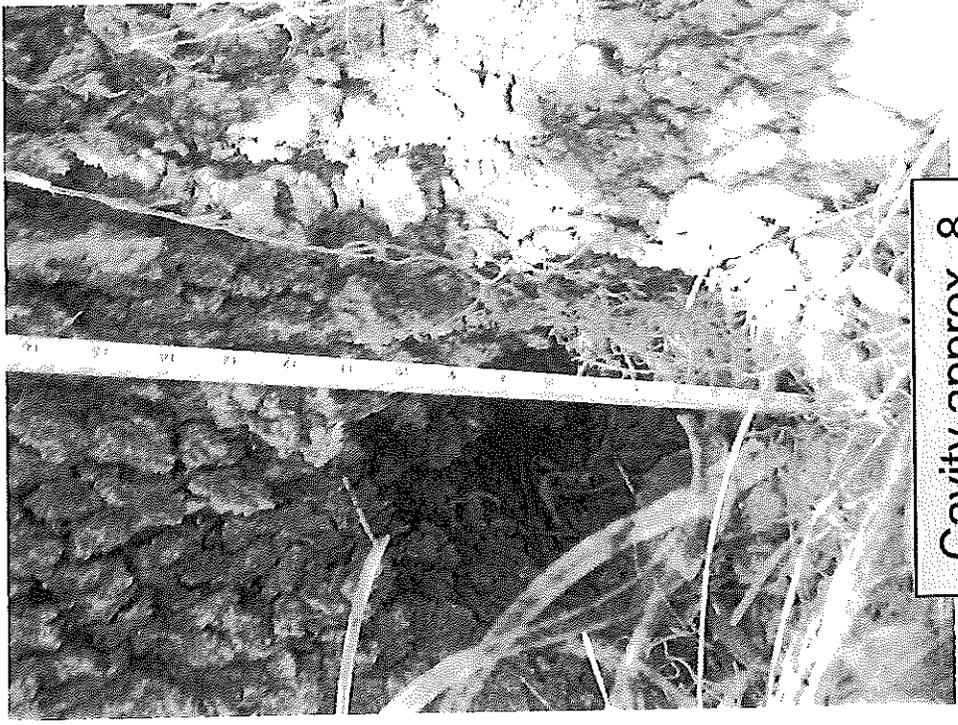
Tree No. 8

Cavity approx. 8 inches in height

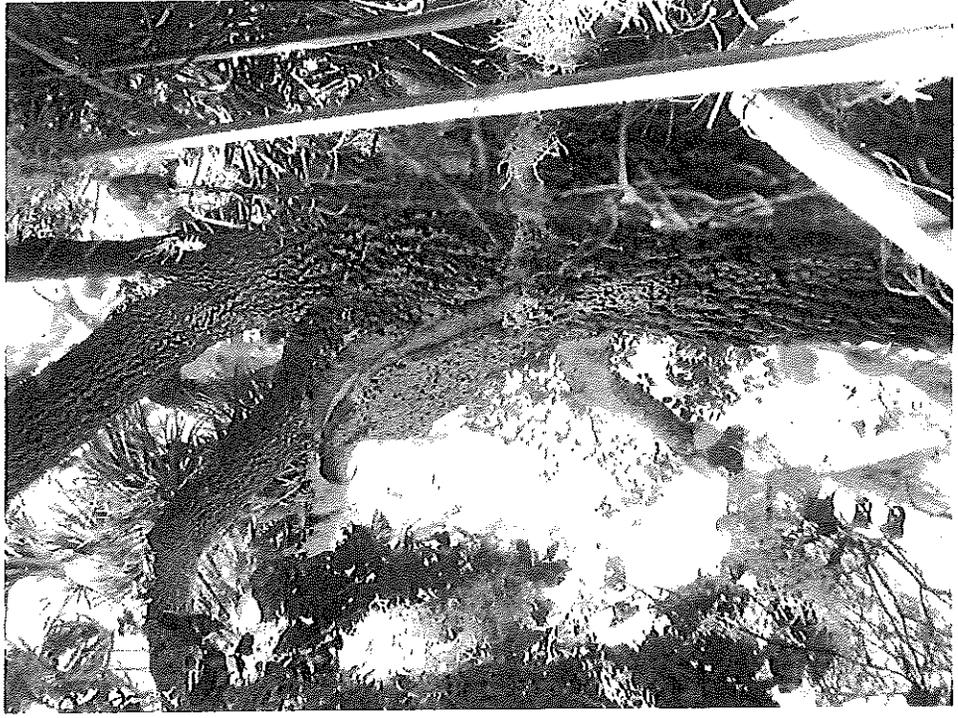
Tree No. 8

Wound with
callus wood &
dead wood

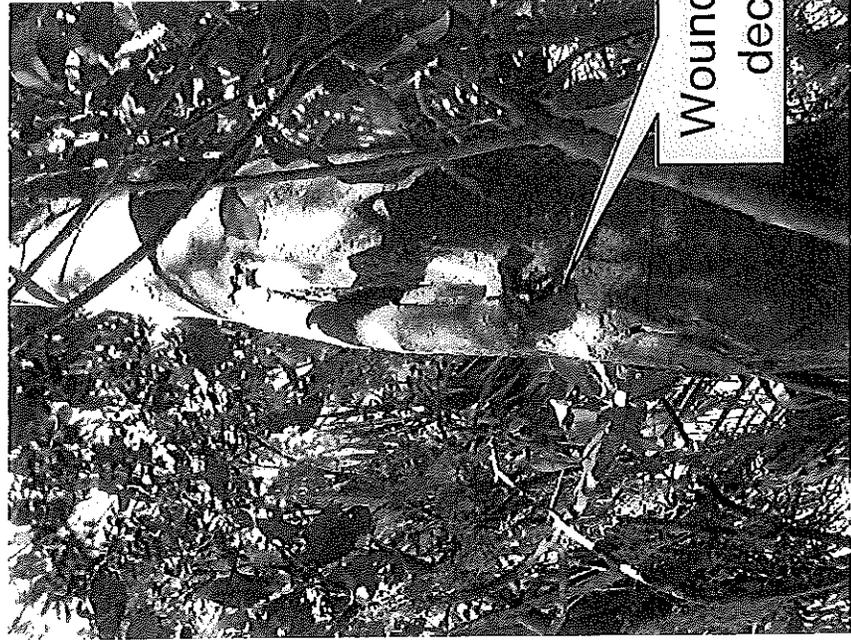
Tree No. 19

Wound with decay

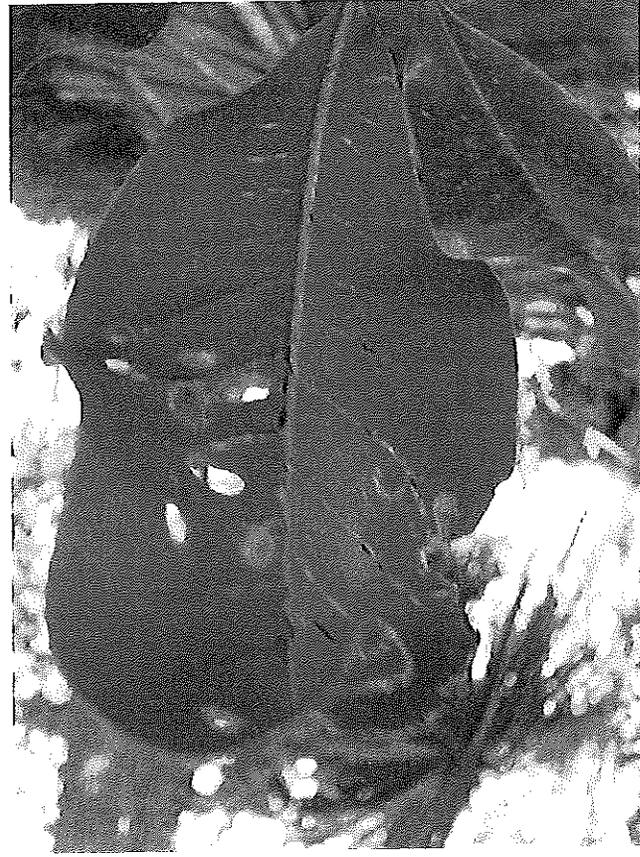
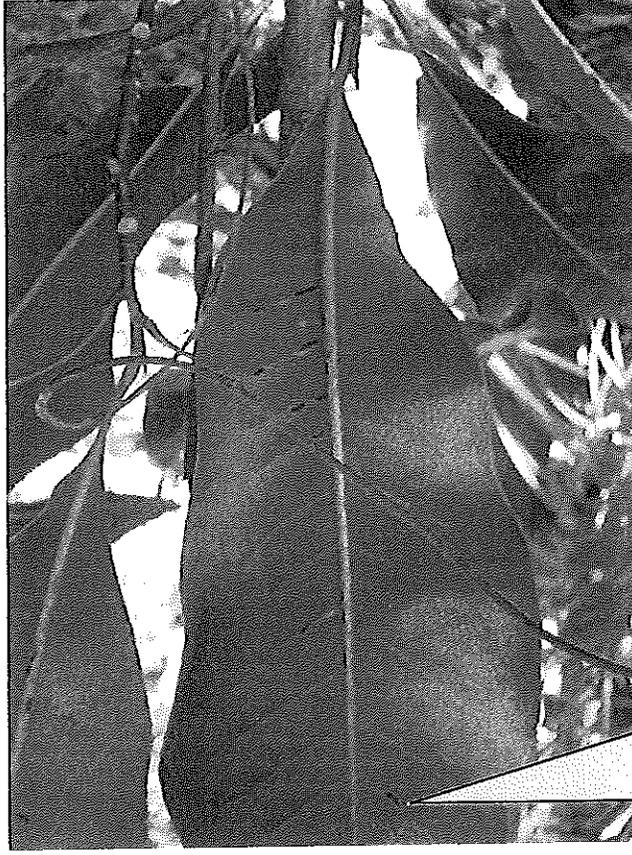
Tree No. 19

“Banana Shaped” Scale

One tree (tree no. 10), a magnolia, was infested with scale. Scales are insects and may cause extensive damage. In particular, scales weaken or kill the host tree (or plant) by sucking plant sap through piercing-sucking mouthparts (Reference: Florida Critters by Bill Zak). This scale is common and a treatment of insecticide oils may help. However, due to the combination of factors with the scale and the wound with decay found on the trunk of the tree, it was determined that this tree is not an ideal candidate to have around a home.

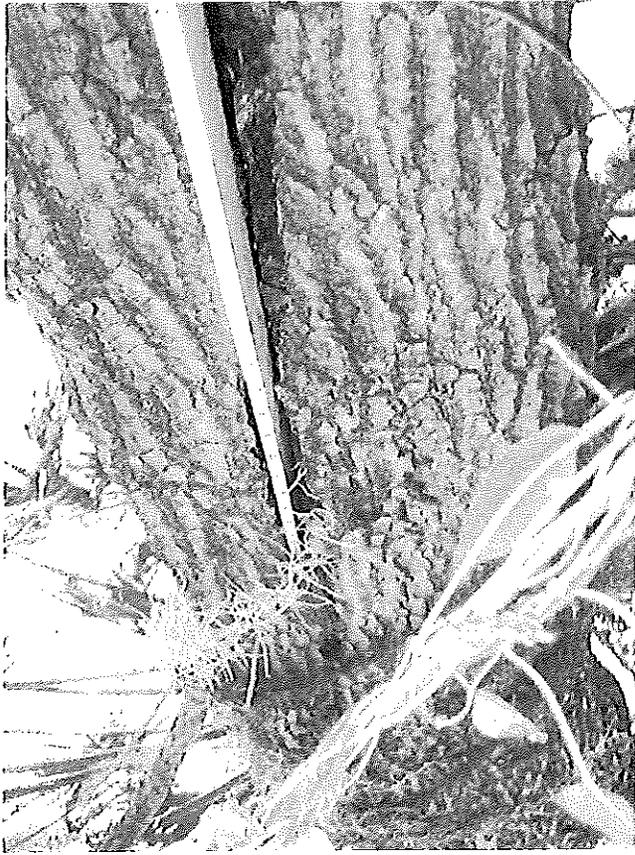
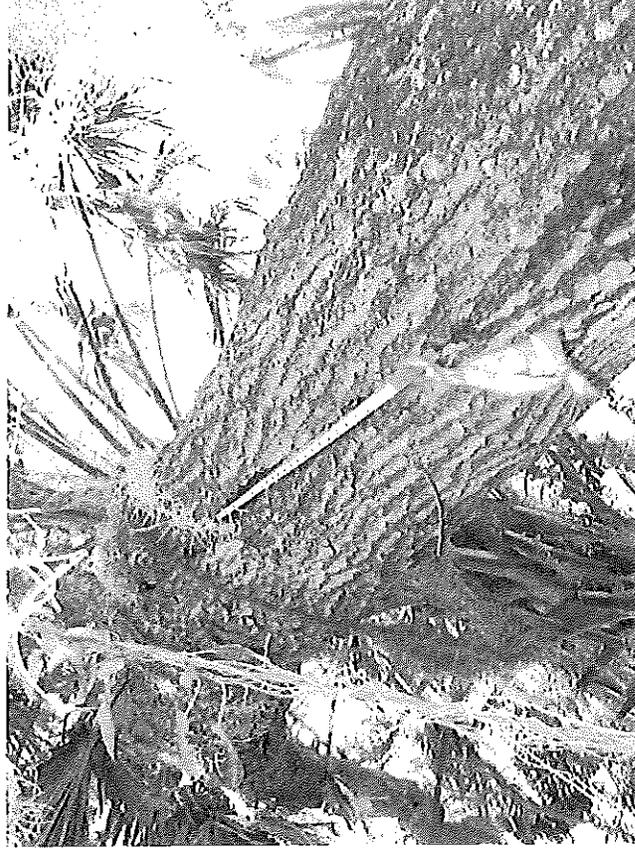
Tree No. 30

28	QULA	12	0.65	Y	Clean crown; some bark inclusion; in cluster with 2 other trees	Crown Cleaning & Preserve
30	QULA	19	0.4	N	Severe lean to the south; crack with decay on trunk of tree; decay on both sides of tree and in multiple points on trunk; reduced canopy	Remove
